US Army Corps
of Engineers

TECHNICAL REPORT REMR-CS-4

REPAIR OF WATERSTOP FAILURES: CASE HISTORIES

James E. McDonald

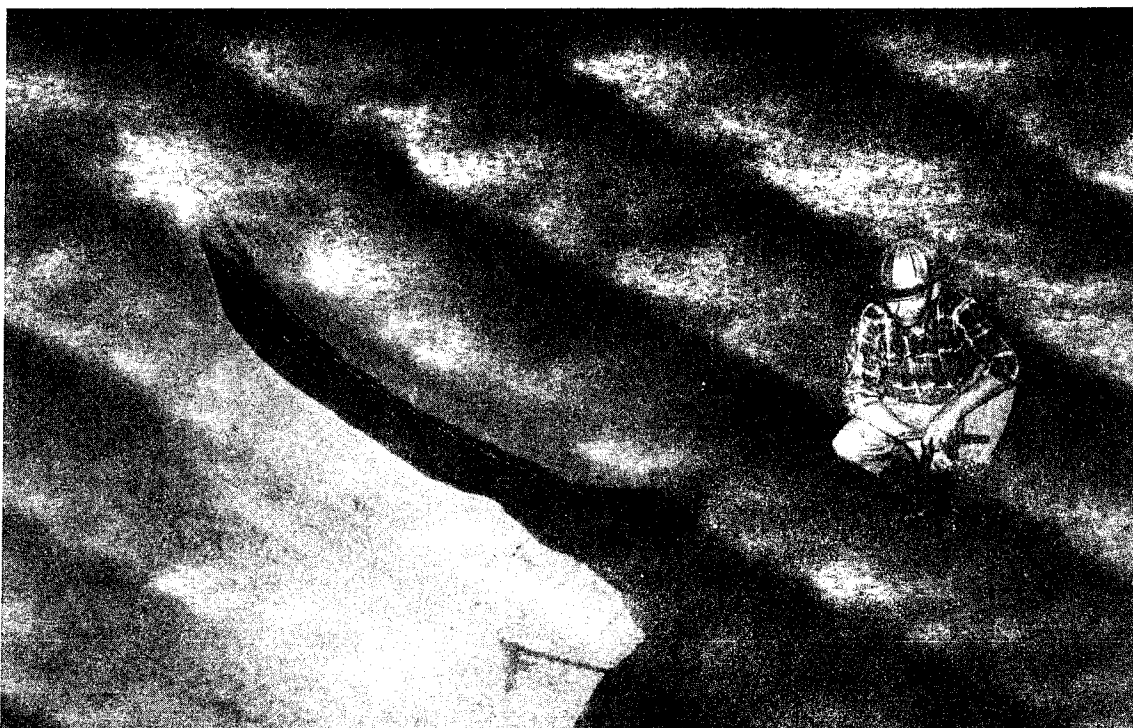
Figure 16. Leakage at conduit joint 4/5, Sardis Dam, 1966

- a. Joints 2/3, 4/5, and 5/6 were repaired at leaking areas by removing the remaining concrete key, packing the joint below the keyway with oakum, sealing the oakum with lead wool, and replacing the key with Skinkote, which is described by the manufacturer, Hallemite Co., Cleveland, Ohio, as a "thin-ply concrete" that will adhere to set surfaces.

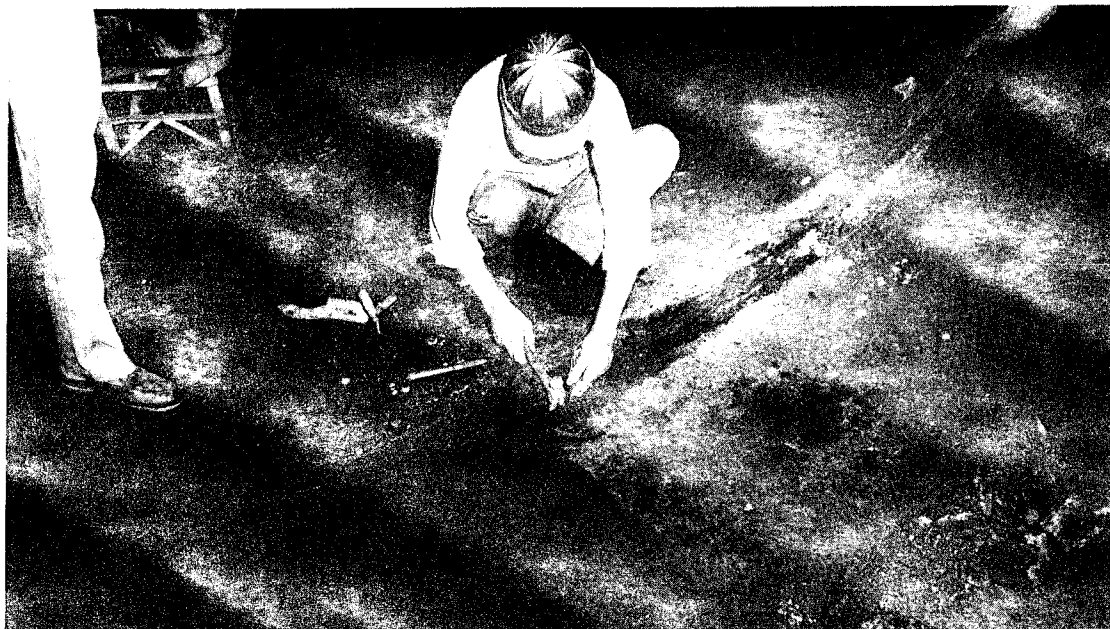
Figure 17. Removal of a portion of the remaining concrete key in preparation for repair, Sardis Dam

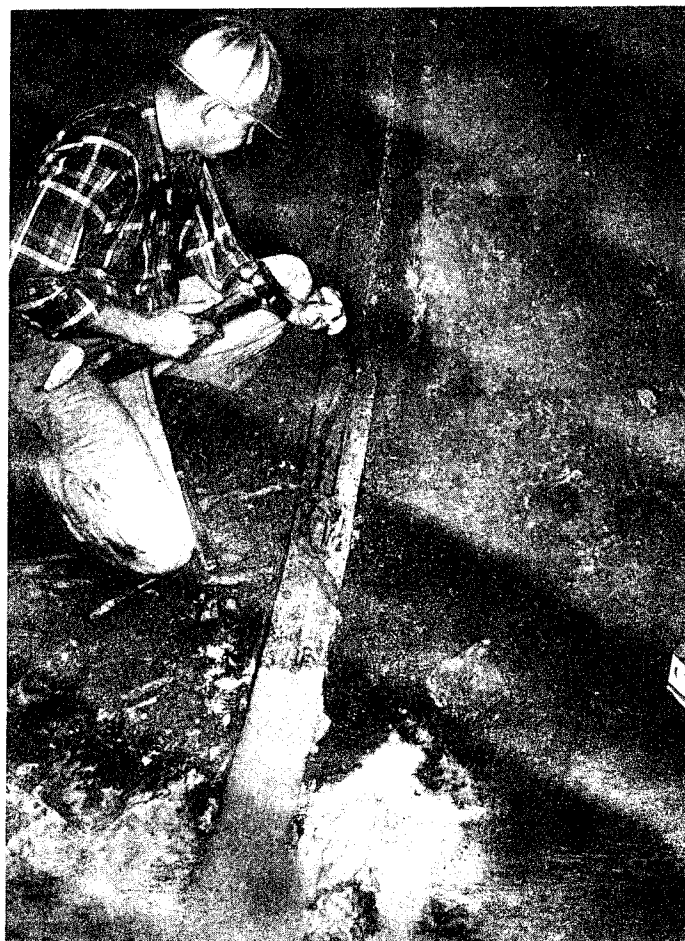
Figure 18. Packing a conduit joint, Sardis Dam

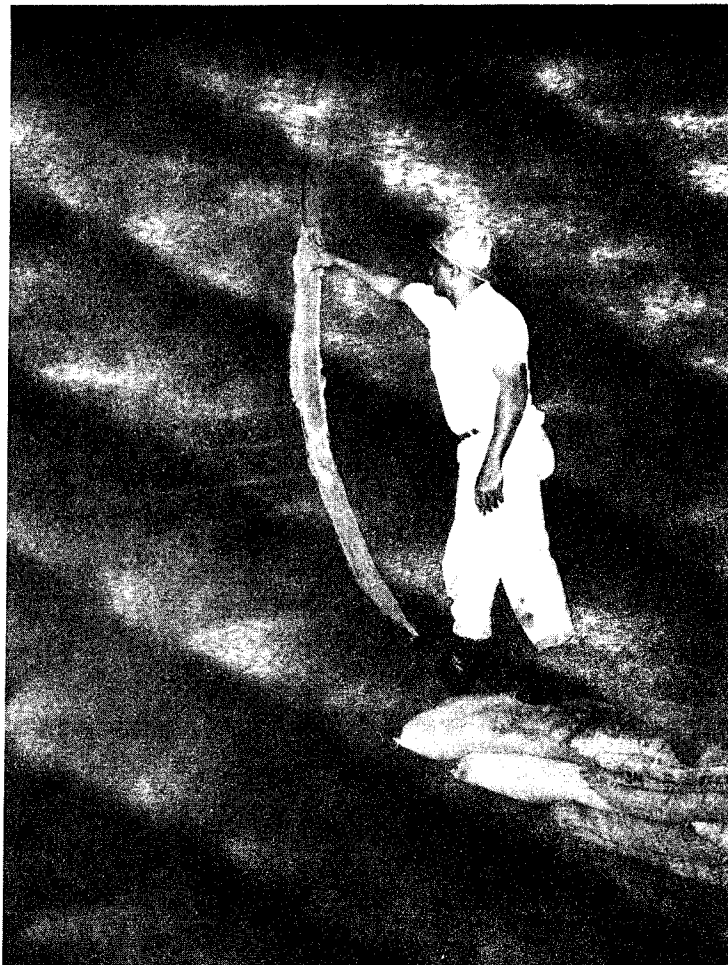
Figure 19. Partially replaced joint keyway,
Sardis Dam

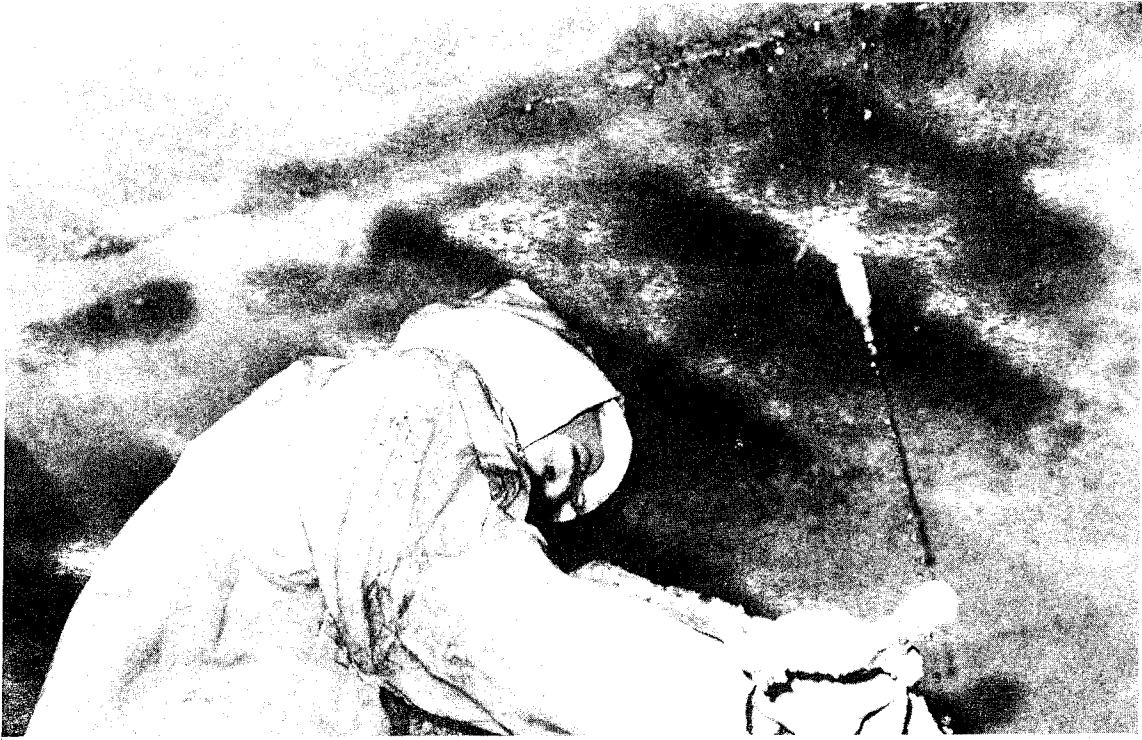
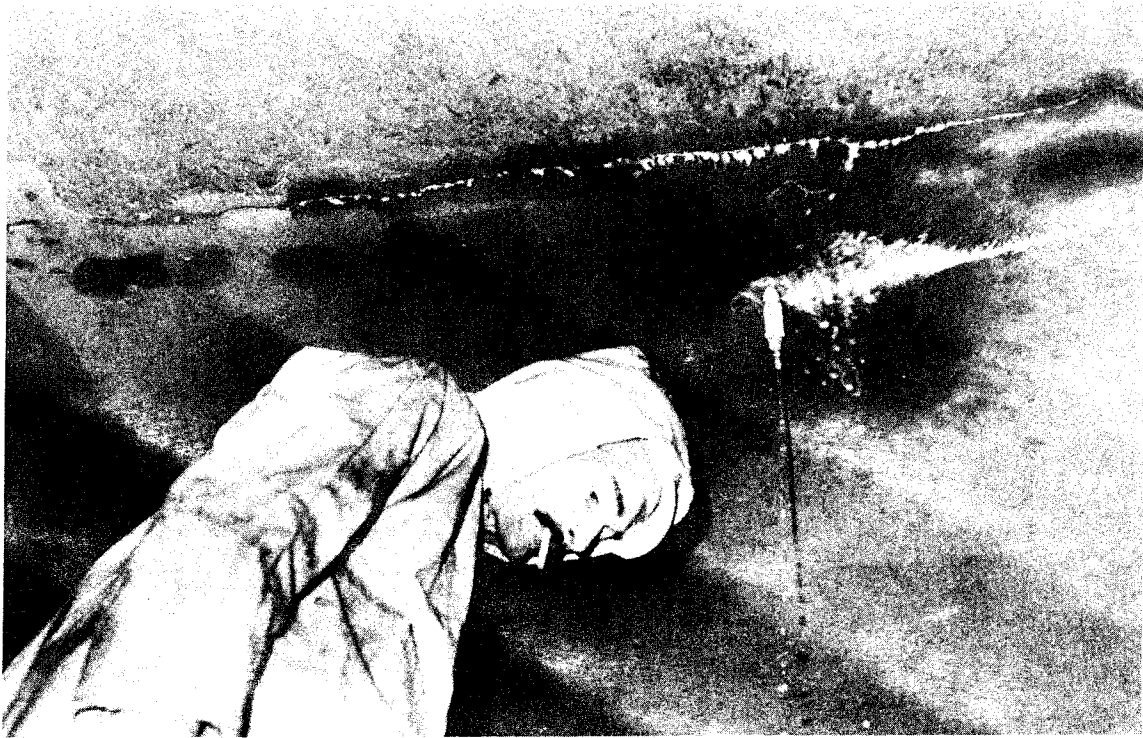
Figure 33. Monolith 10 crack grouting, John Day Lock

a. Prior to grouting

b. Following grouting

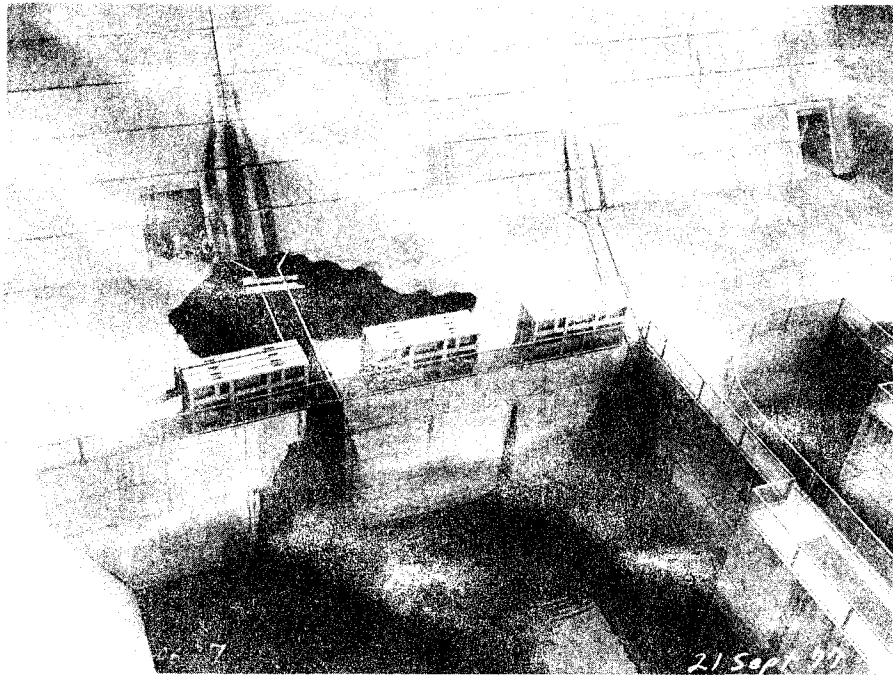
Figure 46. Leakage through north nonoverflow monolith joints, Ice Harbor Dam

127. Under contract in 1978, flexible vertical waterstops were installed along all the navigation lock monolith joints except those joints with full pool on either side of the monolith. Six-inch-diameter holes were drilled along each joint at the lock side of the monolith from the roadway deck down

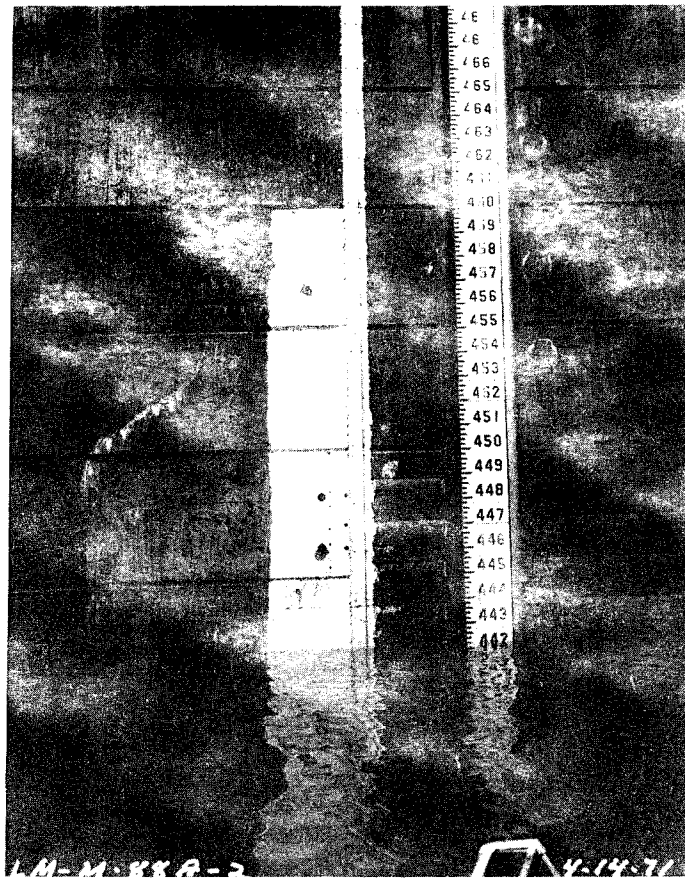
Figure 54. Joint 26/28 repairs,
Lower Monumental Lock

139. Leakage through gate monolith joints 25/27 and 26/28 was repaired by contract while the lock was dewatered in November 1970. A neoprene membrane epoxied to the concrete surface and retained by stainless steel cover plates was used for the repair (Figure 54). The areas which appear gray in Figure 54 have been treated with two coats of an epoxy, Colma-Rote M,

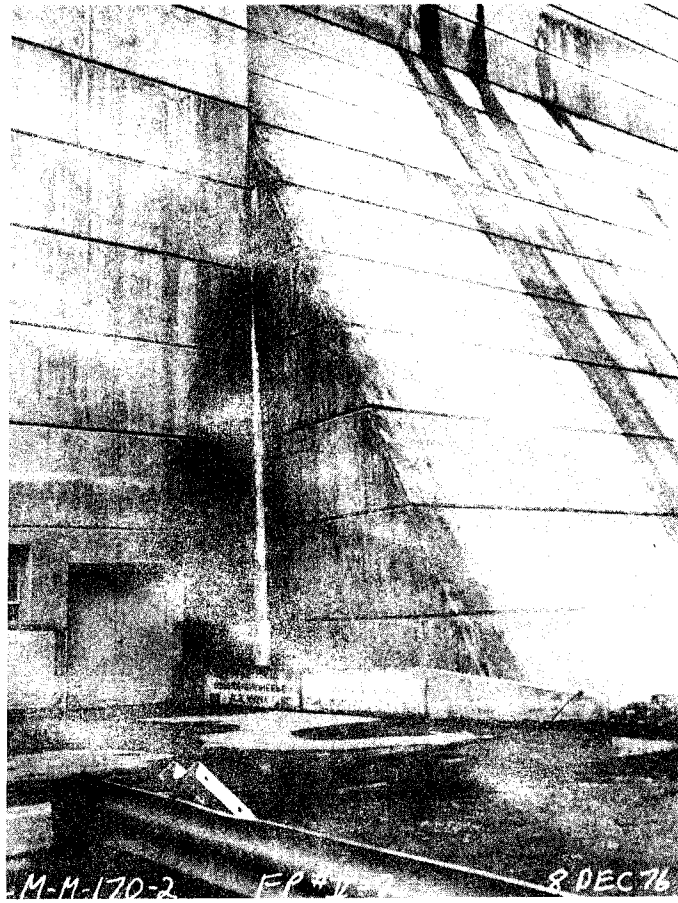
Figure 57. Joint 26/28 leakage, December 1976, Lower Monumental Lock

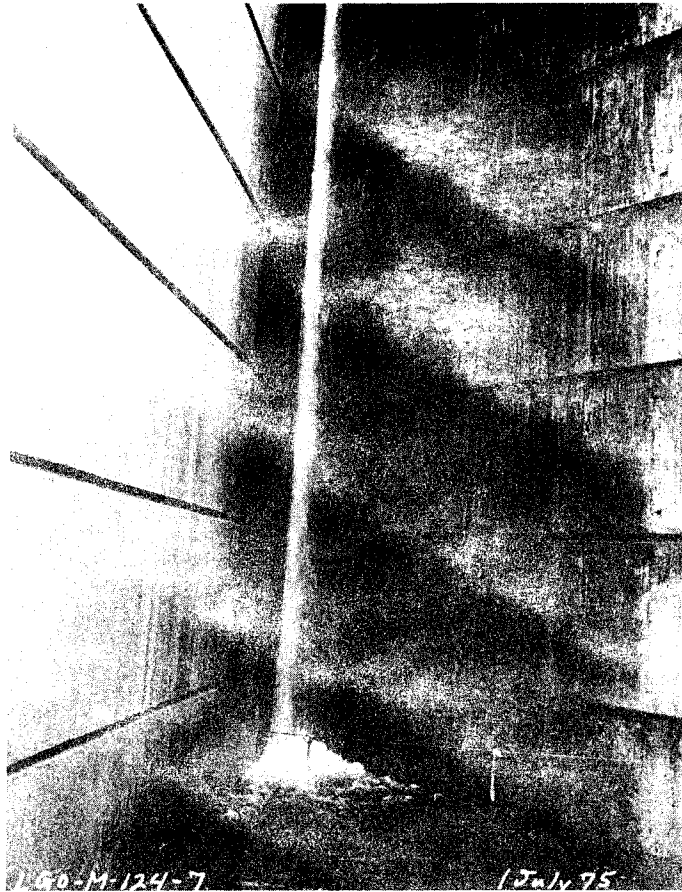
Figure 63. Monolith joint 4/6 leakage,
July 1975, Little Goose Lock

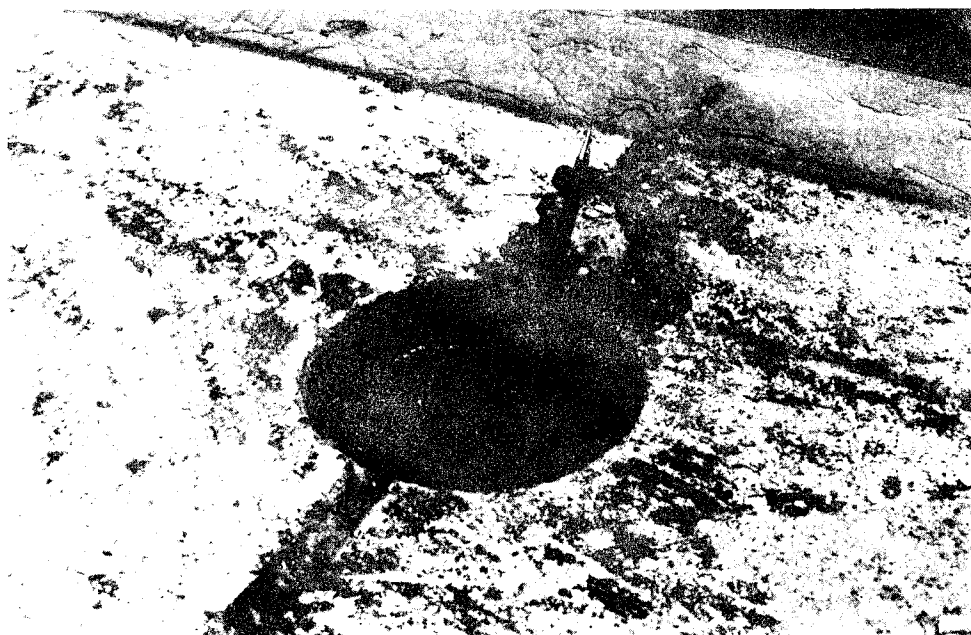
Figure 71. Monolith joint repair, New Cumberland Locks, August 1981

167. Joints in the middle wall were repaired in FY 77 by drilling a vertical 6-in.-diameter hole along each monolith joint to the required depth

and then filling the drill hole with a hot-pour bituminous material (Pennsylvania Department of Transportation asphalt sealer J-1). It was reported in 1981 that the repair appeared to be performing satisfactorily. However, the sealer was very soft and expanded and contracted excessively. When the temperature was cool, the filler was down in the hole, and during a hot period, the filler expanded and pushed out cold patch material previously placed to fill the hole (Figure 71). This was considered to be undesirable by District personnel and it was recommended that other materials be investigated for sealing joints in the future. Alignment and settlement data for the middle wall is shown in Figure 72.

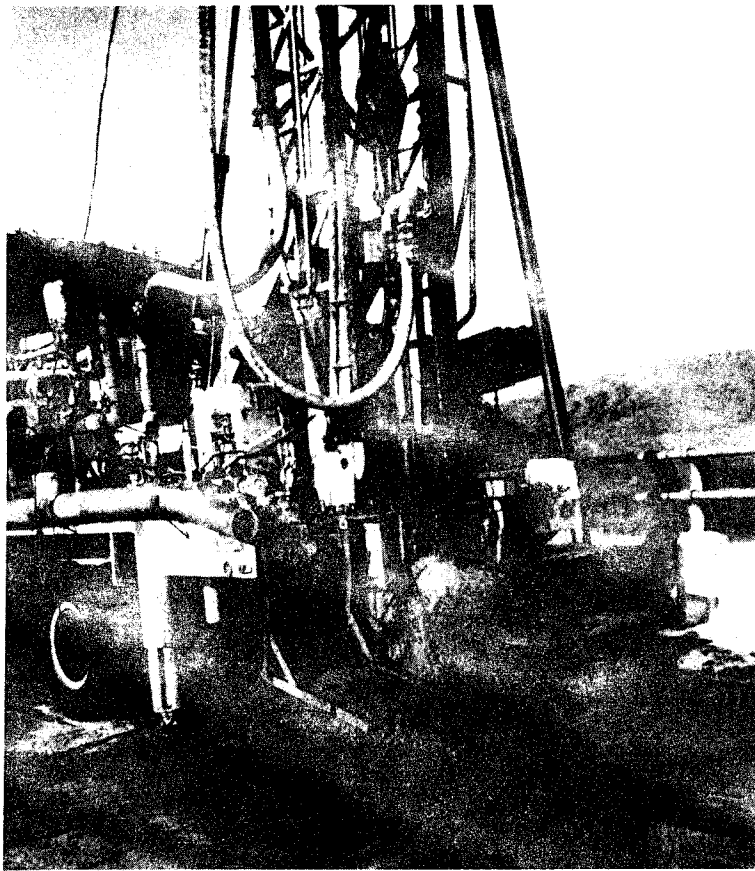
Figure 83. Removal of chemical grout waterstop,
Pine Flat Dam

186. Work on site at Pine Flat Dam began on 20 February 1985. Initially, a rodding truck was used to remove existing grout from the drill hole at joint 30/31. However, the 1/2-in. rod would not enter the hole beyond 20 ft because of the long radius set in the rod. A water jet truck in conjunction with a 165-cu ft/min, 125-psi air compressor also encountered difficulties in penetrating and breaking up the grout. Also, as progress was made, flushing the broken-up grout from the hole became more and more difficult. Removal of grout from hole 30/31 was completed on 27 February 1985. A rotary drill rig was brought on site 28 February to expedite grout removal (Figure 83). Using

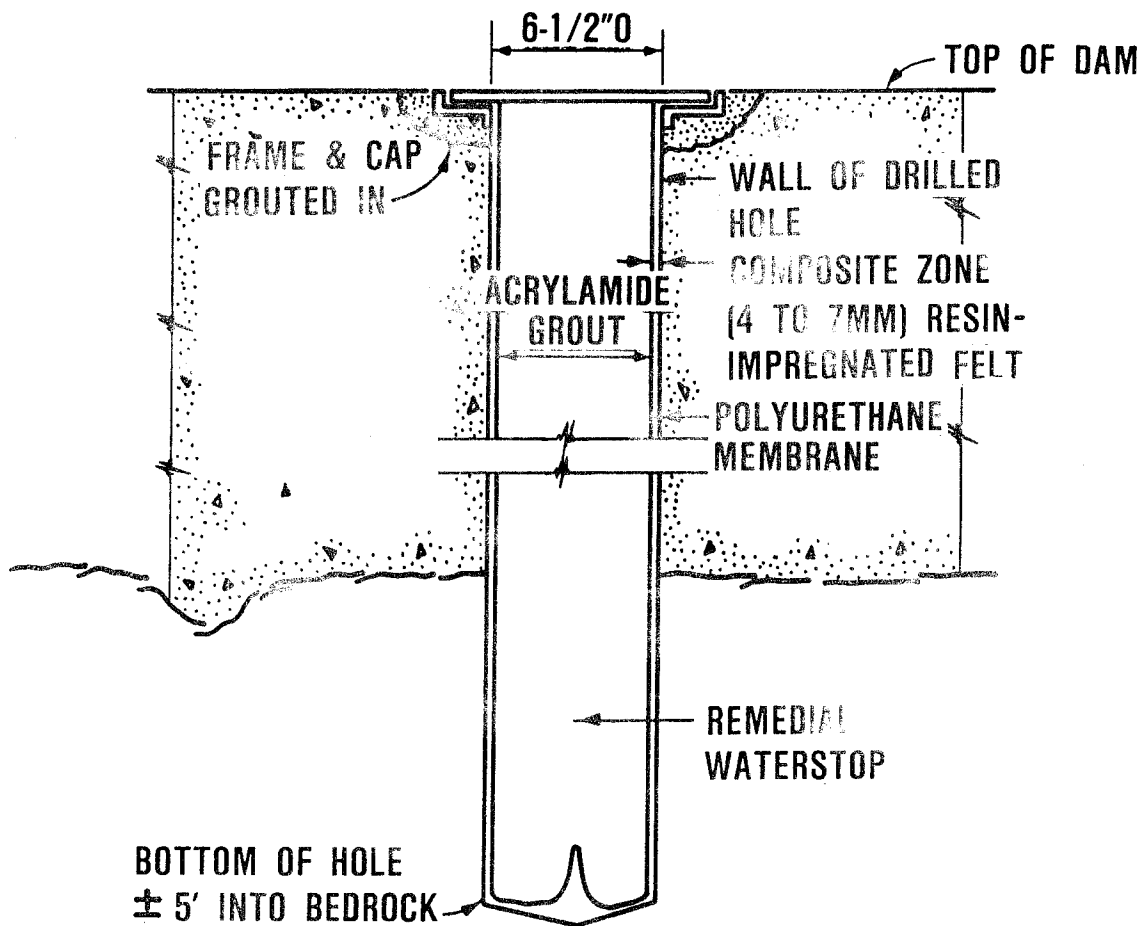
Figure 105. Completed remedial waterstop, Pine Flat Dam

196. A remedial waterstop was installed in hole 30/31 (191 ft deep) on 7 March 1985. As the end of the liner tube approached the bottom of the drill hole, resistance to further progress was encountered. This was mistakenly interpreted to indicate that the bottom had been reached and the control cable was tied off. Later television inspection showed that the tube was within approximately 10 ft of the bottom of the hole. Apparently, the joint near the bottom of the drill hole is relatively tight. Since water within the drill

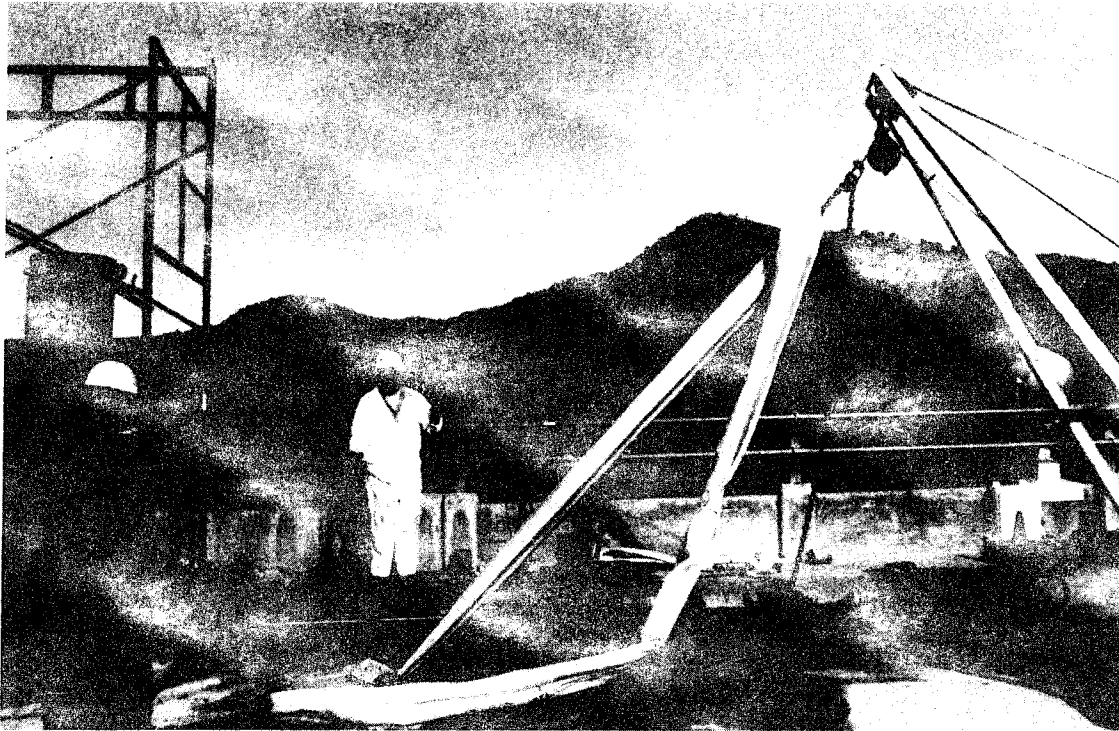
198. An examination of the liner indicated that a stitched seam had failed at a hole depth of approximately 145 ft. This allowed the water to

Figure 106. Removing the aborted tube from hole 29/30, Pine Flat Dam

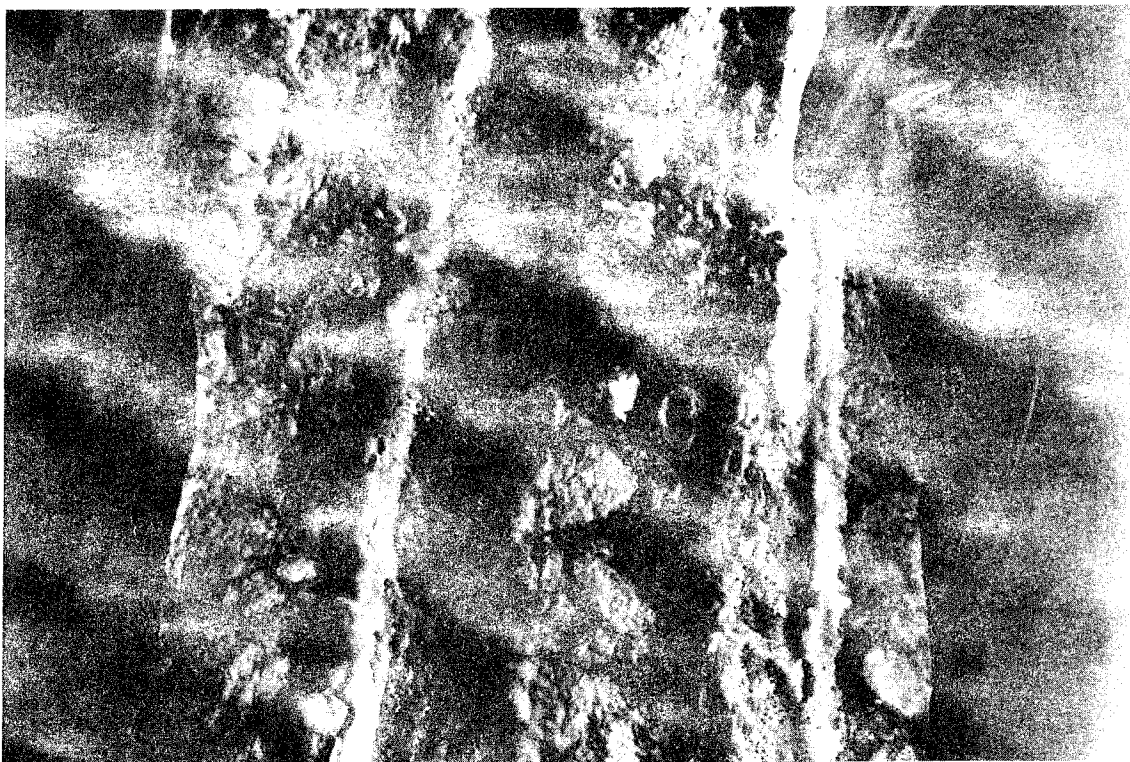
199. The liner tube which was removed from hole 29/30 was dissected (Figure 107) to examine the interface between the resin-impregnated felt and the drill hole. The bond at the interface was obviously well developed since several small pieces of concrete bonded to the felt were pulled out the drill hole wall when the tube was extracted. The outline of aggregate particles could be clearly distinguished from the darker areas of cement paste. Also, two raised strips of resin along the tube indicated that excess resin was being forced into the joint on each side of the drill hole.

Figure 107. Dissected portion of the failed liner tube, Pine Flat Dam

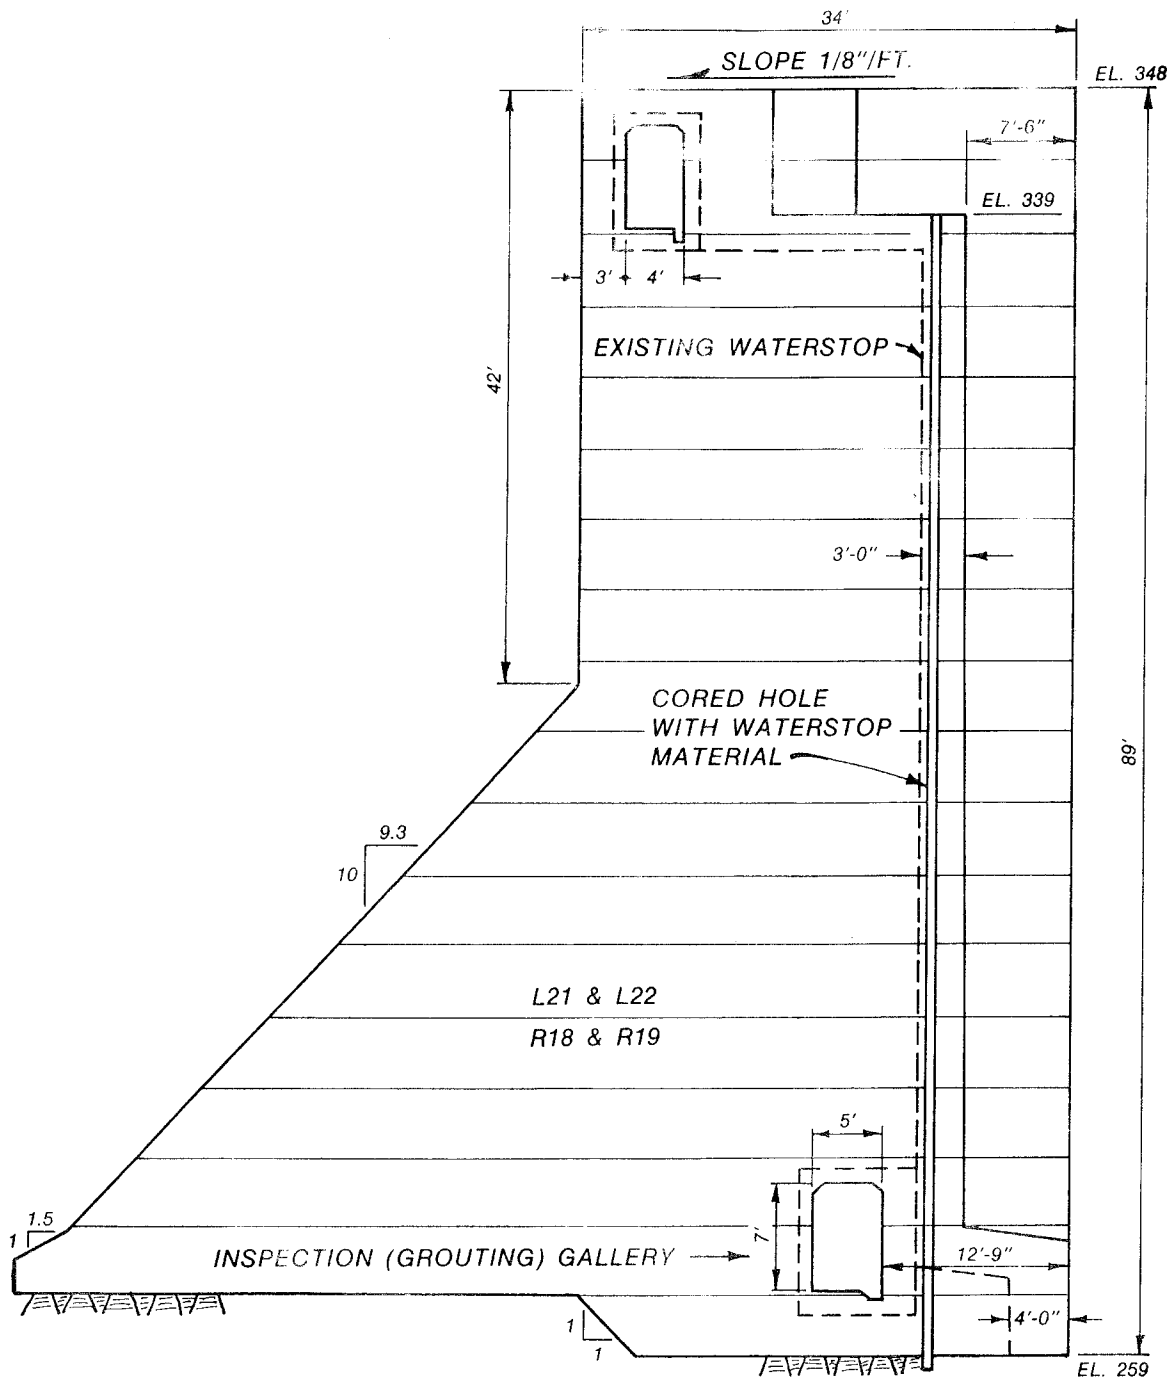
Figure 115. Monolith joint repair, Dardanelle Lock

210. Several methods for sealing the monolith joints were studied before it was decided that the preferred method to stop the leakage was to construct a permanent waterstop similar to the methods used at Lock and Dam No. 3 on the Arkansas River. There, four waterstops were installed in the joints of the right training wall by drilling 6-in. core holes at monolith joints and installing a waterstop device consisting of a neoprene tube filled with an aquagel-baroid-ethylene glycol mixture. The holes at Dardanelle Lock

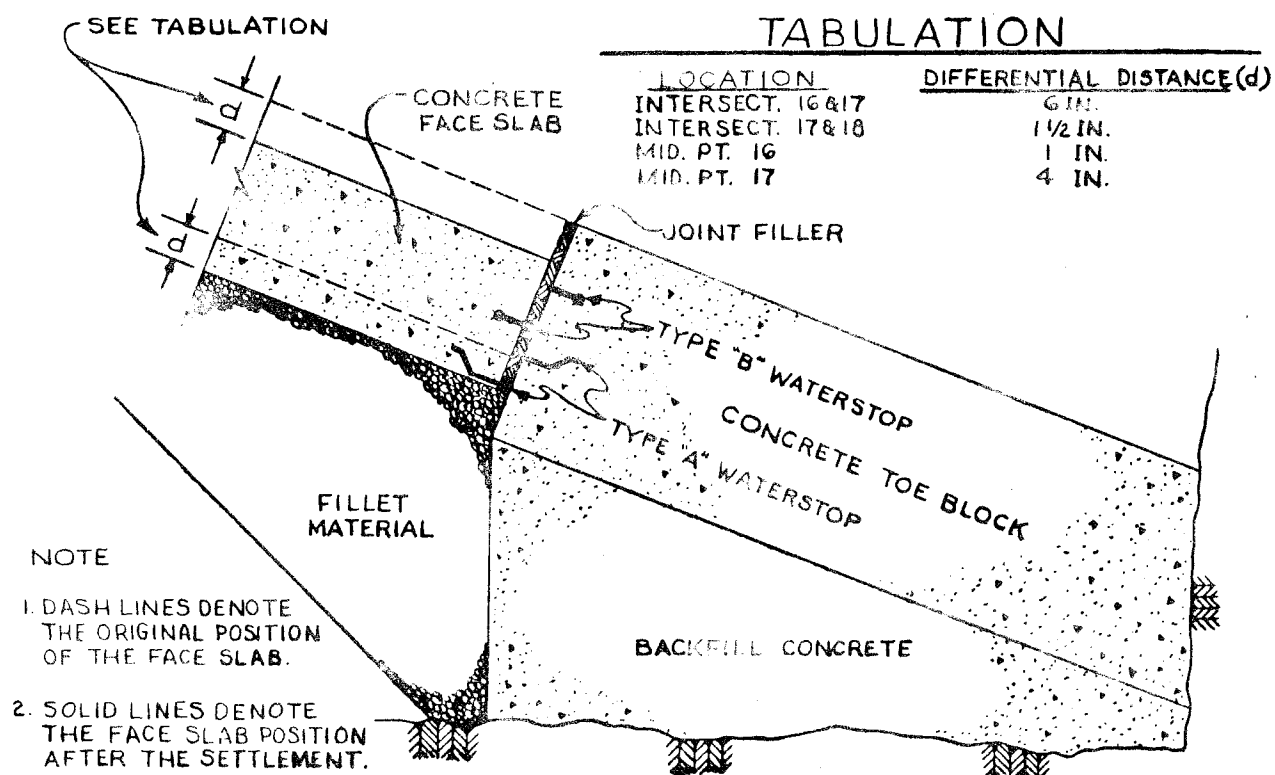
Figure 121. Displacement between face slabs and toe block, R. D. Bailey Dam

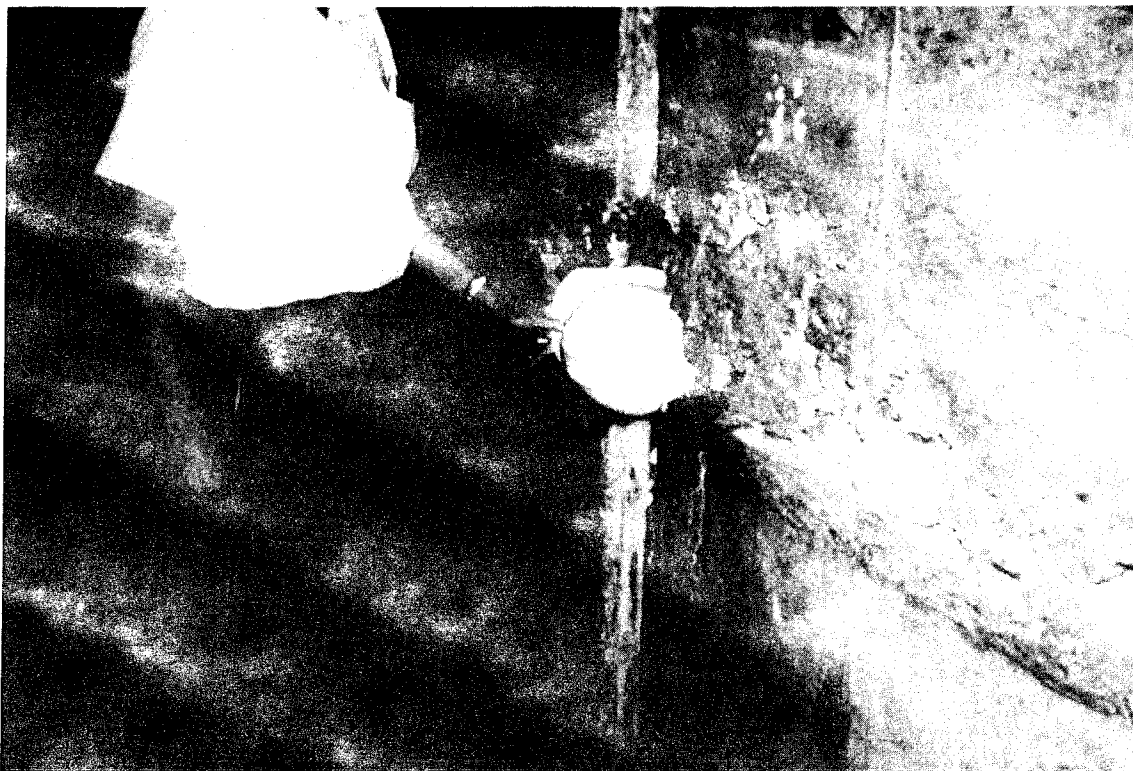
Figure 134. Poorly consolidated concrete adjacent to face drain,
Richard B. Russell Dam, July 1980
